## Cracking the code of CV joint failures

### How advanced SEM technology ensures automotive safety and reliability

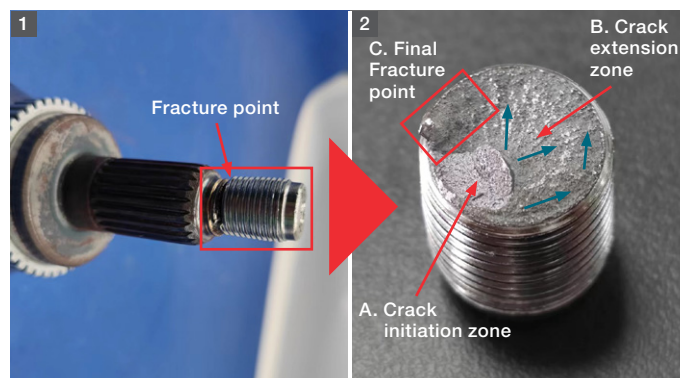
In this case, a CV joint fracture occurred during the assembly process. Most metal failure samples are large, requiring a large sample holder for the SEM that makes it possible to study the complete material on both elemental and on compositional levels.

Figure 1. Outer joint of constant-velocity joint. Figure 2. Macrostructure of fracture.

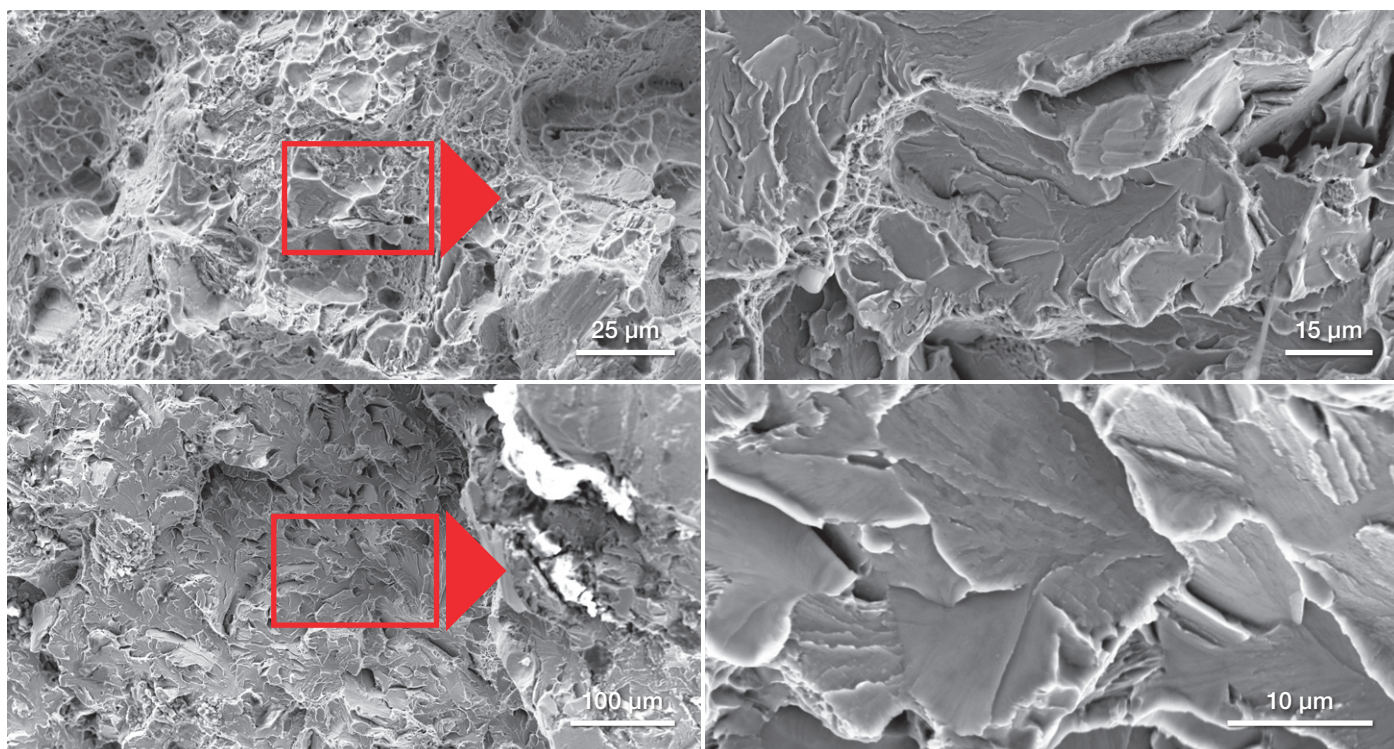
Fig 3 Quasi-cleavage fracture zone.

The secondary electron images in Figure 3 show a so-called quasi-cleavage fracture zone in area A, where minute areas of plastic deformation are visible. River-line patterns are characteristic features of granular (cleavage) fracture, and the connected plateaus show the direction of the crack propagation.

A crack that propagates from inside out of the metal part, like in this case, is likely to be caused by an internal material defect, like a dislocation plane. Analyzing the sample over all the different production steps makes it possible to map the individual steps to their impact on material integrity.
