Novel analysis of single crystal René N5 superalloy

Characterization of high-temperature corrosion and particle analysis with the Apreo ChemiSEM System

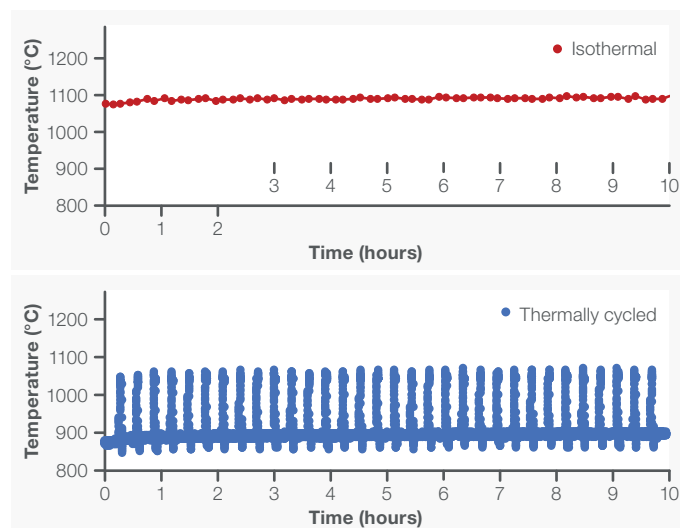
Figure 1. Graphs of time vs. temperature for a portion of the creep tests.

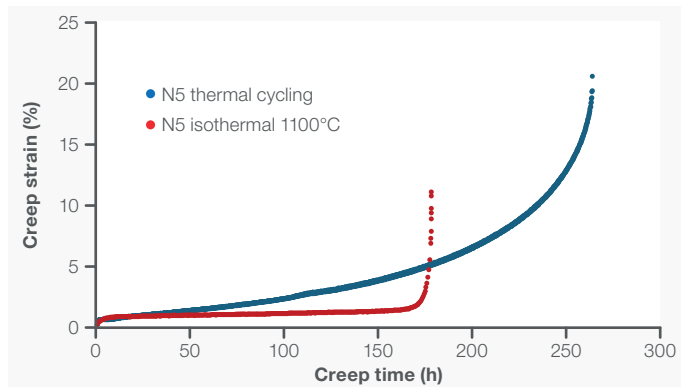
Figure 2. Creep strain percentage vs hours, measured on both the isothermal and thermally cycled samples.

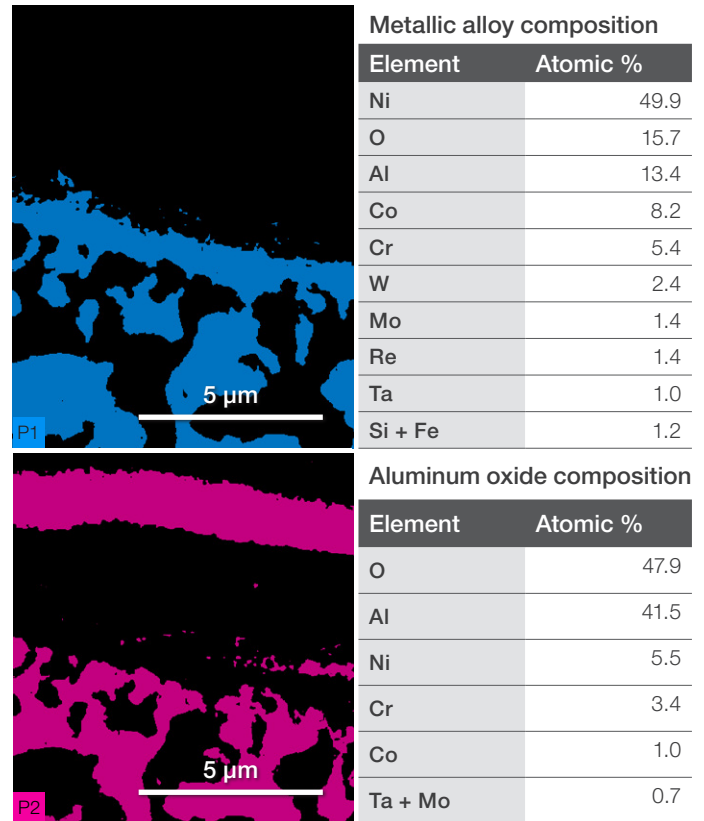
Figure 13. Main alloy (P1) and aluminum oxide (P2) distribution and composition. Data extracted from the ChemiPhase analysis.

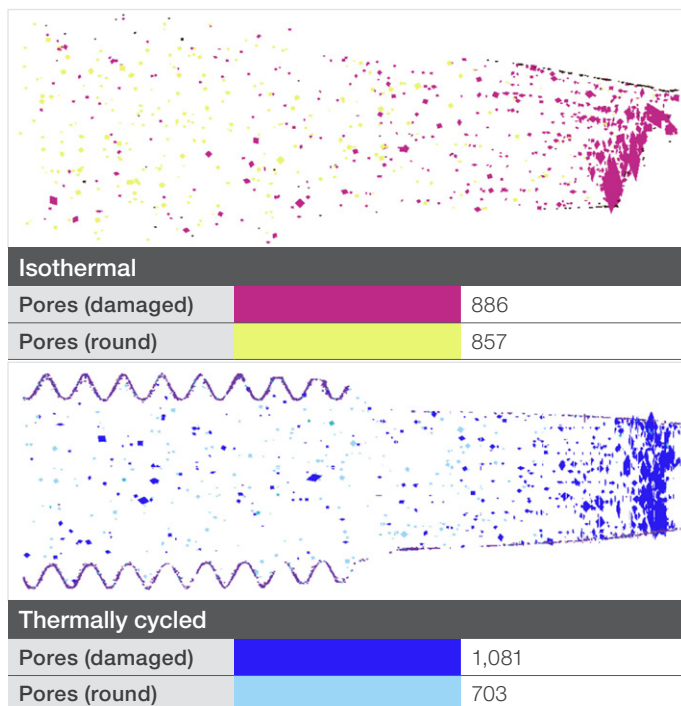
Figure 17. Perception Software particle maps showing selected feature locations.
